DAMAGE DUE TO ELECTRIC SPARK DISCHARGE MACHINING OF ZINC*

by A. P. L. Turner, K. H. Adams**, and T. Vreeland, Jr.

W. M. Keck Laboratory of Engineering Materials
California Institute of Technology, Pasadena

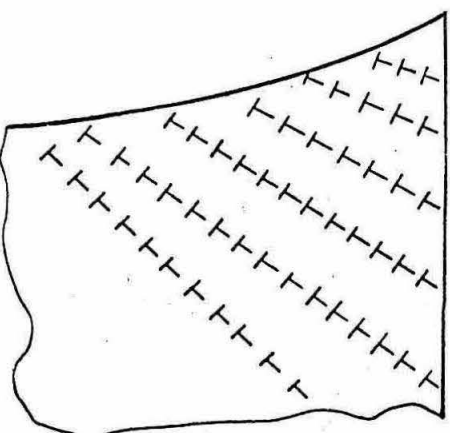
Fig. 3. Schematic illustration of spark machining damage.

(a) Concentrated load and resolved shear stress.

(b) Edge dislocations driven into crystal by the resolved shear stress.

(c) Kink bands and bulge produced on left edge of specimen.

A mechanism is proposed below which describes the formation of the observed damage and is consistent with the deduced character of the loading. During the planing operation the specimen is subjected to repeated impulsive point pressure forces resulting from the collapse of cavitation bubbles. Cavitation is known to occur because the electrical discharge causes a rapid vaporization of the oil in the immediate vicinity of the spark. Dislocations are generated at the surface and in the vicinity of the spark. A concentrated load on a free surface produces resolved shear stresses on the basal glide plane which are the same sign everywhere in the highly stressed region as shown schematically in Fig. 3a. This stress configuration will drive dislocations of one sign into the crystal while those of the opposite sign are driven to the surface as shown in Fig. 3b. Near one edge of the crystal the resulting concentration of edge oriented dislocations of a single sign can polygonize to form a series of kinks which extend from the planed surface to the side surface as illustrated in Fig. 3c. At the other edge of the crystal the dislocations will be driven out of the lateral surface of the crystal. The average pressure on the planed surface is sufficient to cause the kinks to move from the edge into the crystal by

glide and to form the slip bands observed near the other edge. The 45° orientation is the most favorable for the formation of kink bands and slip. For this orientation the strain energy associated with the kinks is a minimum while the resolved shear stress on the dislocations is maximum. The resolved shear stress is insufficient to cause severe deformation during the planing of surfaces oriented 10° or 80° from a basal (0001) plane.
